Technical Note

CLIENT:	TATA Steel UK
PROJECT:	Project EAF
SUBJECT:	Coal Mining Risk Assessment
JOB NO.:	ST20879
DATE:	12 April 2024
PREPARED BY:	Adam Clarke, Engineering Technician
APPROVED BY:	Rebecca Marvell, Technical Director

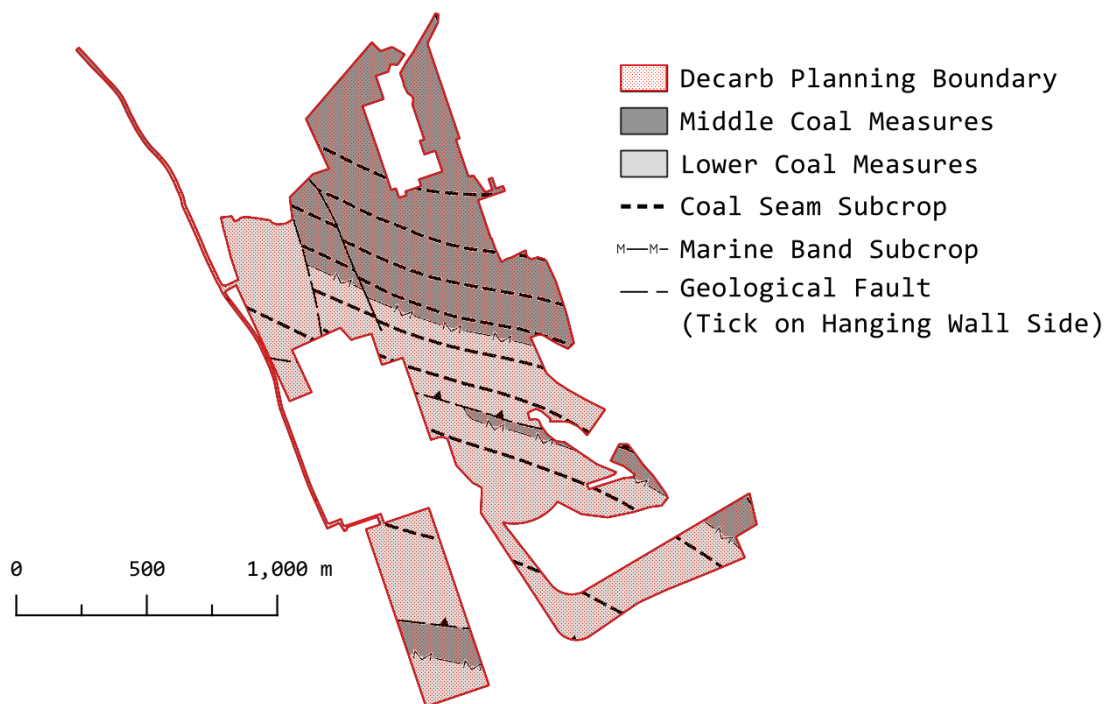
Figure 1 Geological structure within Planning Boundary. Contains British Geological Survey materials © UKRI 2024

Several geological faults subdivide the stratigraphy at the site. The Kenfig-Tytlwyn Thrust Fault crosses through the site in an approximate east-west direction and offsets (throws) the geological sequence. The offset is such that several named coal seams are thought to subcrop within the site on both sides of the fault. BGS records also describe additional faulting (Giant's Grave fault and Morfa fault) at the site; but without detailed investigation, the conjectured position, and throw of these faults cannot be accurately determined.

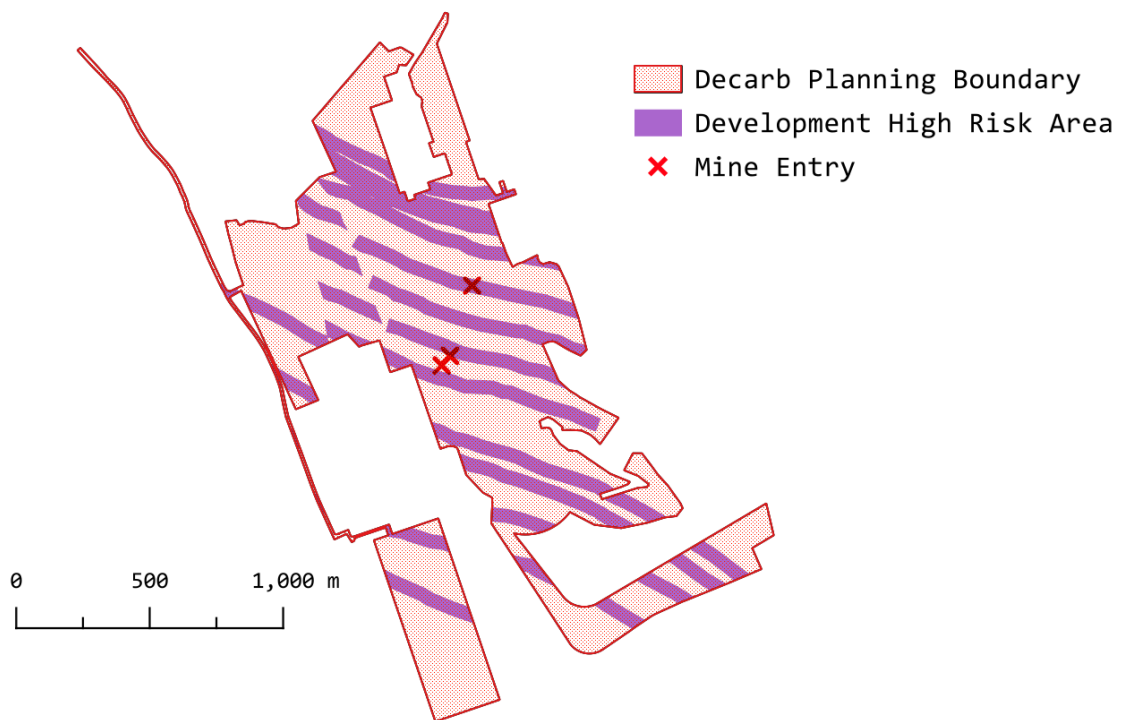
Figure 2 Development High Risk Areas to be revised following CMRA and ground investigation. Coal Authority information © The Coal Authority, 2023

Three mine entries are recorded by the Coal Authority within the provided Planning Boundary. Wardell Armstrong has previously carried out physical searches for the three mine entries, physically proving the position of one shaft and providing search records for the other two.
